## CARAVAN COUPLING FAILURE

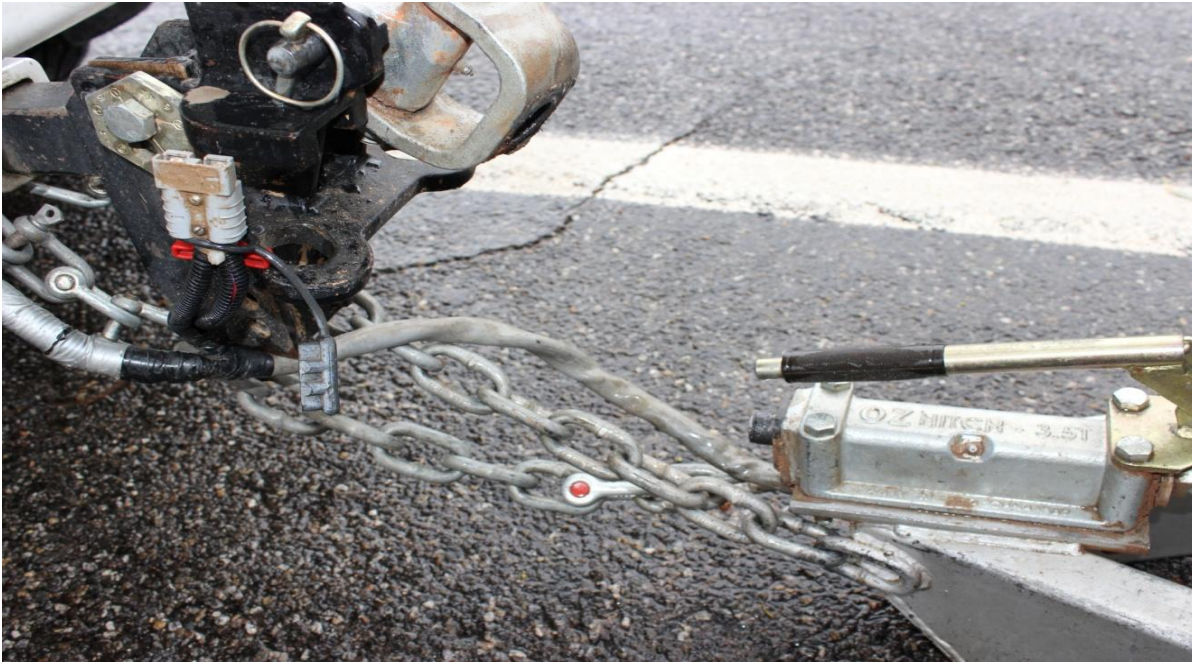
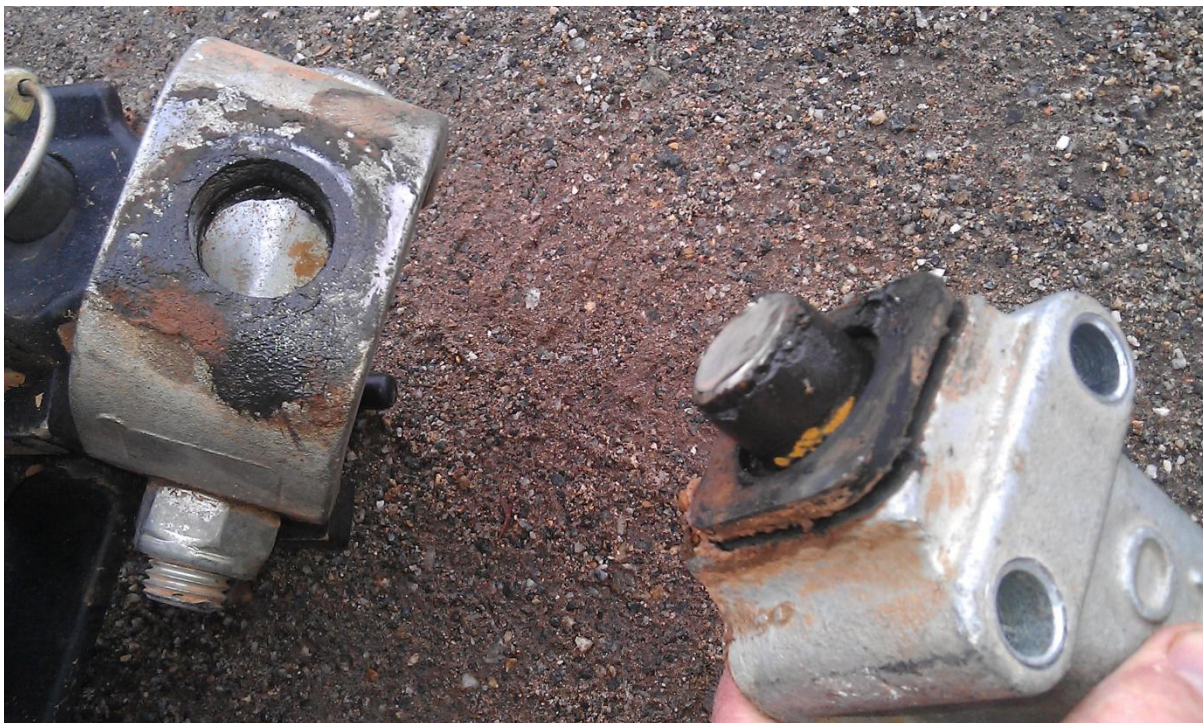
On Saturday 31 May 2014 I was executing a U turn, and half way through the turn, the coupling failed. This was caused by a failure of the spigot shaft weld on the rear end of the coupling.

I have been subsequently told that the welded area was between the high tensile steel shaft and cast steel coupling.

On the day of the failure, I contacted the manufacturer, Oz Hitch and advised them of the situation to which they replied "we have had a few failures of these, we are happy to replace the unit". "The new units have the shaft threaded and then welded".

I have provided this information so that the word can be spread to people that have these hitches and to contact the manufacturer Oz Hitch or have their coupling fully checked out.
